Ballistic Perforation of Graphite/Epoxy Composite

Piyush K. Dutta, Dennis Farrell, Susan Taylor,
Aziz Tadayon and David Hui

December 1996

Special Report 96-29

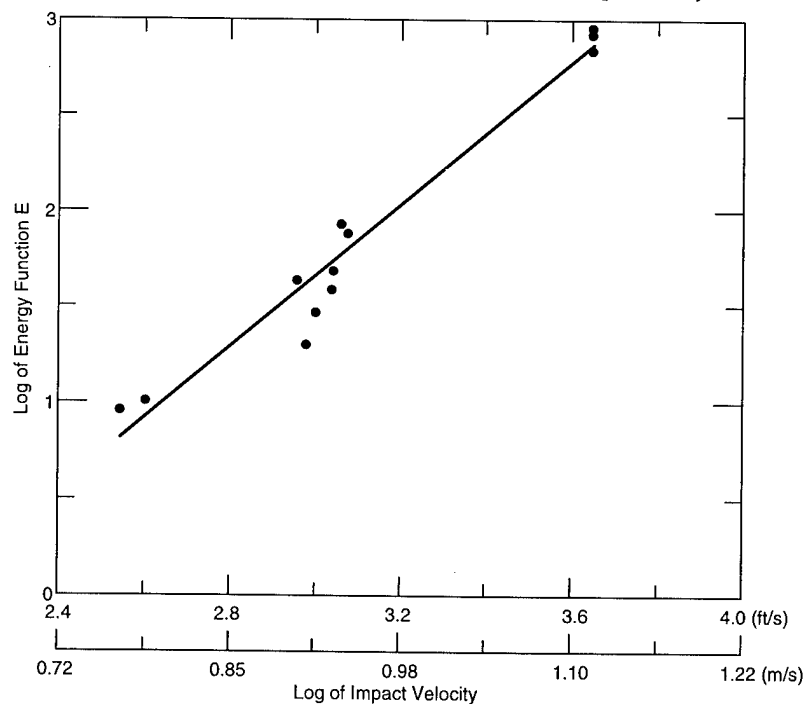
Figure 1. Ballistic test results of 31-ply Gr/Ep plate 12.7-mm steel sphere impact.*

istics and the impact velocities on the penetration response of these composites. More specific objectives include development of a methodology to characterize and analyze post-penetration fracture surfaces both in macro- and in micro-scale. Earlier work conducted by Altamirano (1991) and Mayer* (Fig. 1) demonstrates an empirical relationship between the energy absorption function E and the impact velocity V as:

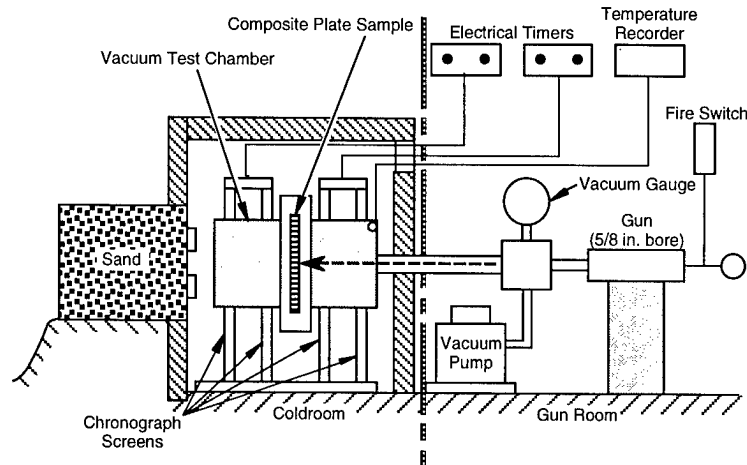
a. Schematic of ballistic test facility.

Figure 2. CRREL ballistic test facility and gun system.

The CRREL Terminal Ballistic Facility (TBF) is shown schematically in Figure 2a and in an assembly photograph in Figure 2b. The entire facility is located in four adjoining rooms: the firing room, the control and instrumentation room, loading room, and the cold target room. The firing room is lined with a 20-cm-thick concrete wall. The room is equipped with a 14.3-mm ($9/16$ -in.) bore, explosive-powered gun that can be remotely operated from the control room. The barrel end and the projectile path are completely sealed with a 127-mm- (5-in.-) i.d. steel pipe, which passes through the wall of the firing room into the target room. The target room can be refrigerated to a tem-

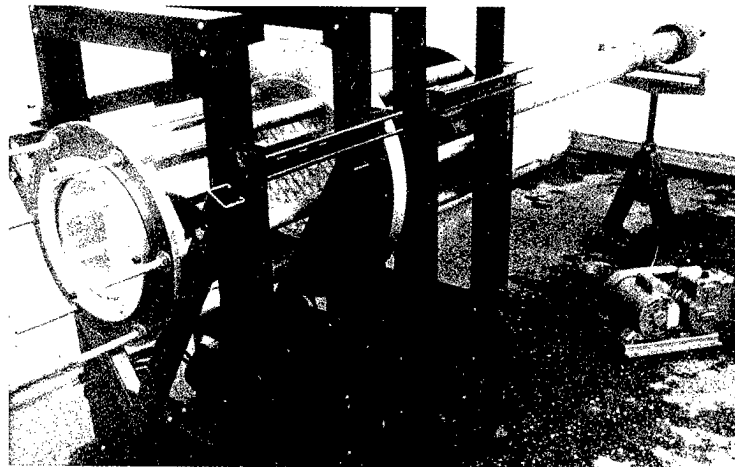
b. Assembly of the ballistic test gun system.

perature of -25°C (-13°F). The end of the seal pipe terminates into a specially designed plexiglass chamber (Fig. 2b). It is equipped with two metallic holding plates to clamp the composite target test plates at the periphery for normal impact. The target test chamber is connected to a back-chamber of the same diameter and length, and also it is completely sealed to maintain interior vacuum when needed. The back-plate of the chamber, made from plastic, is replaceable after every shot. The projectile exiting through the back-plate is captured by a sandbox located in the flight path opposite to an opening in the wall. For high velocity (>610-m/s, 2000-ft/s) tests the interior of the gun barrel, seal pipe and the test chamber must have a very high vacuum pressure, which is achieved by connecting the pipe interior to a vacuum pump. For low velocity tests no vacuum is necessary.

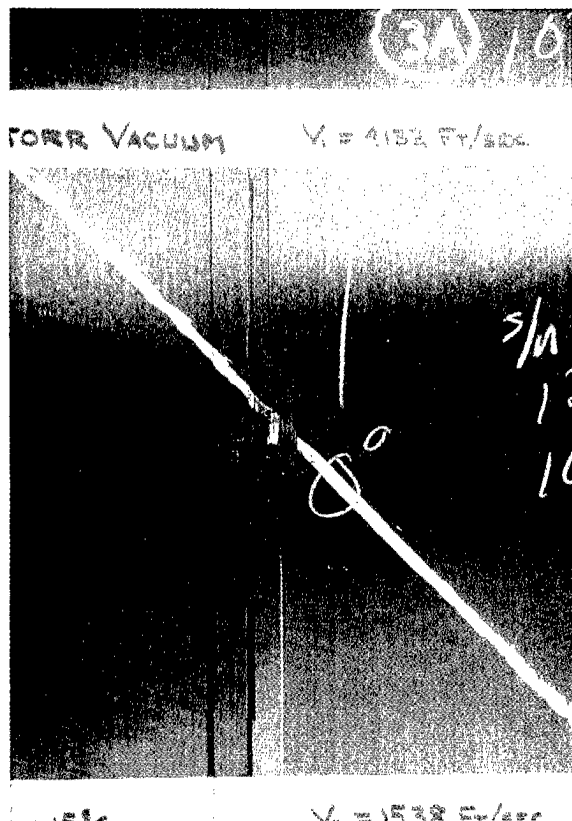
Figure 3. Typical specimen of the unidirectional Gr/Ep specimen after test.

No attempt was made to capture the fragments from the impact on the unidirectional composite. The focus of the unidirectional composite impact test was to identify the gross damage pattern developed on the composite. The fragments from the quasi-isotropic composites were collected on the adhesive coated papers that lined the interior of the target chamber on both the impact and exit sides. Figure 3 shows one typical perforated plate of unidirectional Gr/Ep, and Figure 4 shows a carefully cut section through the 30-ply quasi-isotropic Gr/Ep.

The damage in the unidirectional laminate was simple to interpret. Because of severe anisotropy of the stiffness and strength properties, only longitudinal cracks in fiber direction propagated. The primary failure in the impact zone was obviously indentation followed by fiber breakage, delamination, and finally shear plugging. Numerous longitudinal cracks split the specimens in a large number of longitudinal strips (Fig. 3). Figure 5 shows the effects of velocity on the damage process of the unidirectional Gr/Ep. Notice that the shear plug-out hole for the high-velocity impact (approx. 4500 ft/s or 1400 m/s) has a much cleaner outline (Fig. 5a) than the one at lower velocity (Fig. 5b). It seems likely that at higher velocities more momentum is trapped in the shear plug than at low velocities. At lower velocities the fibers break upon impact of the projectile, and then flex with shear failures propagating longitudinally to the boundaries of the specimens.

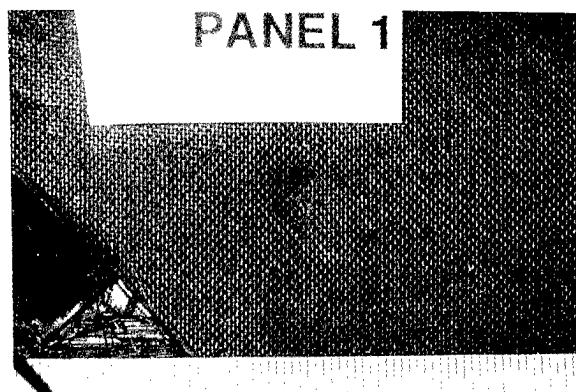
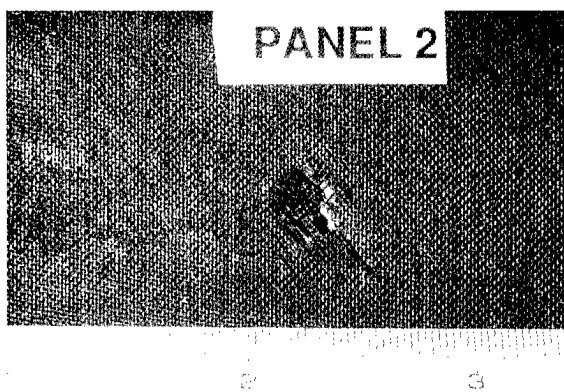
a. Low velocity impact damage (unperforated).

b. High velocity impact damage (unperforated).

Figure 6. Impact damages to quasi-isotropic composite plates.

Figure 6a shows a very low velocity (88.4-m/s, 291-ft/s) impact of the steel ball on the 30-ply Gr/Ep laminate. The energy of impact in this case was not sufficient to cause perforation. (Ballistic tests

performed at the U.S. Air Force Wright Laboratory* show that the V_{50} velocities for this type of laminates would be about 137 m/s [450 ft/s].) Nevertheless, damage by delamination and fiber breakage did happen as evident from the slight bulging of the rear surface and an ultrasonic scanning (C-scan) examination performed on this laminate. At velocities around V_{50} a typical damage looks like the one shown in Figure 6b, which was obtained at 151 m/s (496 ft/s). The perforation was complete in this case. The high velocity (975-m/s, 3200-ft/s) perforation type damage on these laminate was rather extensive. Figure 4 shows a cut-out section through the perforation hole of the high velocity impact. The cutout was carefully made without disturbing the positions of broken lamina and fibers. Notice that the damages on both impact and exit sides are more extensive than at the center. Delamination damage is more in the rear side, whereas the impact end has more crushing and fiber breakage.

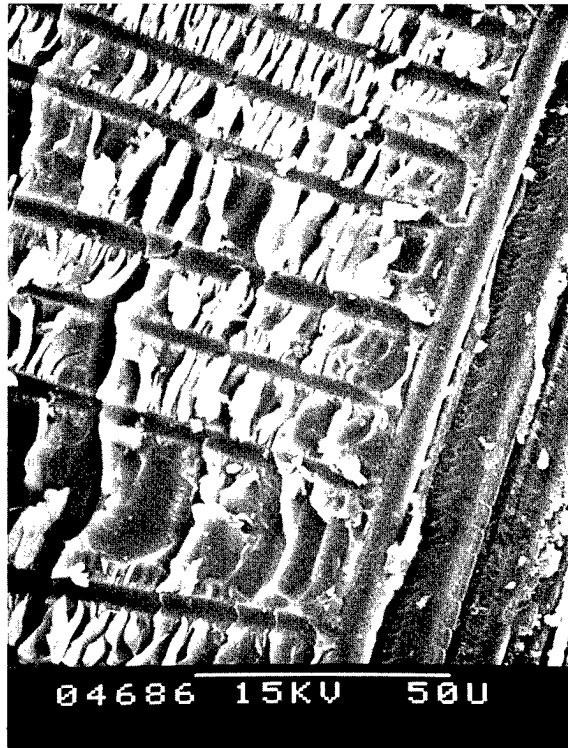
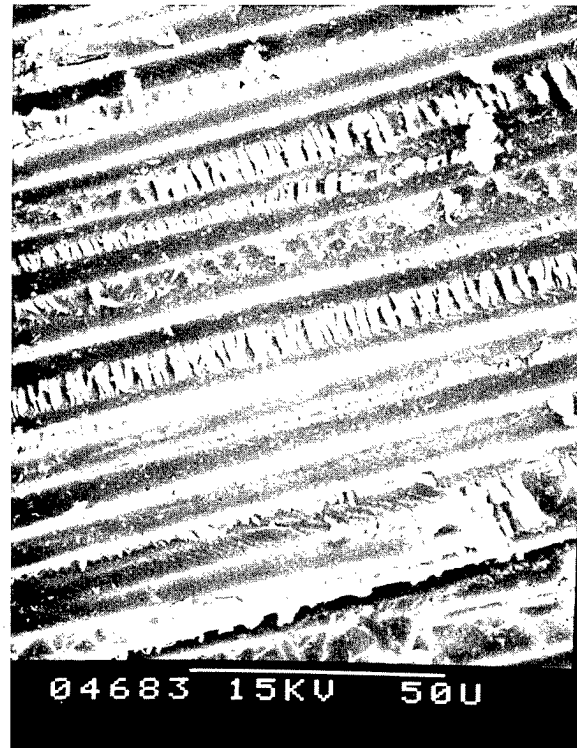
a. Micrograph of sample A.

b. Micrograph of sample B.

Figure 7. Very high velocity impact fragment fracture surfaces.

seemed to contain interlaminar joint surfaces. Fibers oriented in 45° and 90° angles are clearly visible in these fragments. Many of the samples in this category of tests showed hackle marks (Fig. 7a, b).

hackle marks in fracture surfaces would primarily indicate an impact induced damage, and proliferation of hackle marks on our ballistic fragments clearly indicates this trend (Fig. 7 a, b).

The hackle marks present a periodic formation of sigmoidally shaped ridges and troughs running roughly parallel to the fiber direction and located in the matrix region between them. There is a spatial periodicity perpendicular to the direction of the fibers, which is the first suggestive observation. The second observation is that the wavelength of these hackle marks appears to increase as the distance between the neighboring fibers increase (Fig. 7a). The wavelength of the hackle mark is of the order of interfiber distance. Sometimes, the ridges appear to be canted at an angle to the fiber axis.

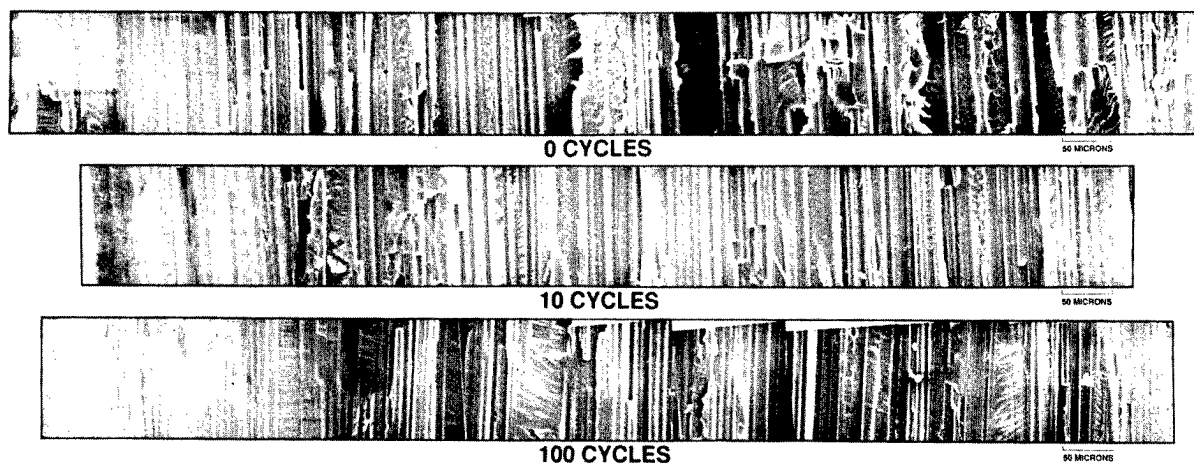
Figure 8. Scanning electron micrographs of a 7-ply AS-4/3501 laminate transverse fracture surface from static tension test after low temperature thermal cycling (Dutta and Taylor 1989).
